Properties of Wide BandGap Materials

INTRODUCTION

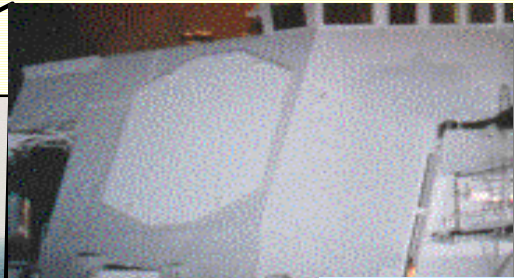
Surface Navy Radar

Aperture size constraints:

S-band: 32 m²

X-band: 10 m²

- NAVY REQUIREMENTS FOR LONGER RANGE DETECTION, DISCRIMINATION & COUNTERMEASURES CHALLENGE FUTURE RADAR DESIGNS.
- NAVAL ARCHITECTURE LIMITS ANTENNA APERTURE SIZE.
 - ⇒ REQUIRE **HIGHER POWER RF AMPLIFIERS**
- CANNOT BE PROVIDED BY CURRENT GaAs TECHNOLOGY.
- NEW HIGH POWER AMPLIFIER TECHNOLOGIES NEEDED TO MEET FUTURE NAVY REQUIREMENTS.
- THESE REQUIREMENTS CAN ONLY BE MET USING **WIDE BANDGAP POWER AMPLIFIERS.**

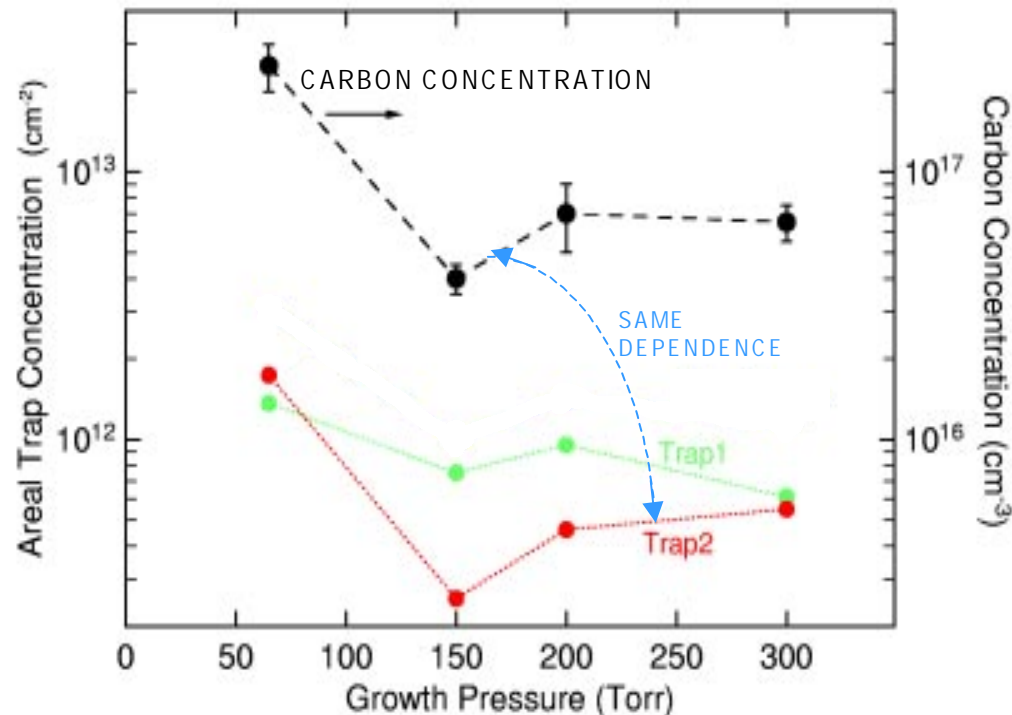
Defect Identification from Photoionization Spectroscopy

- Defect incorporation affected by material growth conditions.
- Variation of Trap1 & Trap2 concentrations with material growth pressure:
 - Concentration of Trap2 TRACKS concentration of **CARBON**.
 - **Trap2 is carbon-related defect.**
 - Reduction of carbon expected to reduce this effect.
 - Trap1 concentration varies similar to **structural defects**.
 - Current studies probing this relationship.
